Bulletin – HSV600

P1	05.12.17	Preventive measures	PIT	RSD	JSV
Doc. Rev.	Issued date	Reason for Issue	Made by	Checked by	Approved by
Servi AS Bergmannsveien 241 3615 Kongsberg, Norway Phone: 64 97 97 97 kongsberg@servi.no www.servi.no

Document Title:				
Bulletin - HSV600 – Working section				
Servi Project No:	Order No.:	Doc. No.:	Servi Rev.:	Page:
		1848660	A1	1 of 3

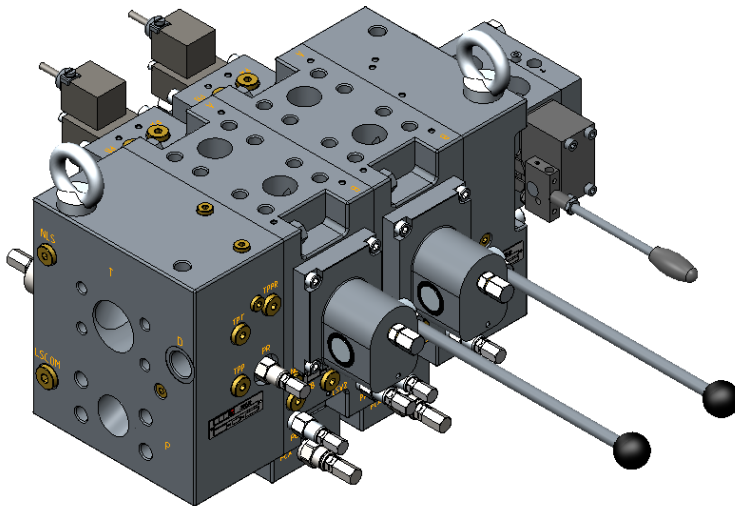
Figur 1 – HSV600 assembly

We may have discovered a case where the rocking lever item 38 (see Figur 2) loosens and unscrews from position. This may cause damage to the cover on lever side, and lead to contaminants in the system.

1. Loosen screw item 32 (see figure 2) with 19 mm wrench
2. Check rocking lever item 38 (see figure 2) with 6 mm hex key
3. Fasten rocking lever item 38 (see figure 2) with torque 120 Nm
4. Fasten screw item 32 (see figure 2) and make sure bonded seal item 3 (see figure 2) is in place
